BROOKDALE SENIOR LIVING INC. et al.,

Case No. 4:17-CV-03962-HSG (LB)

**DECLARATION OF DOUGLAS J.
ANDERSON IN SUPPORT OF
DEFENDANT'S RESPONSE IN
OPPOSITION TO PLAINTIFFS' MOTION
FOR CLASS CERTIFICATION**

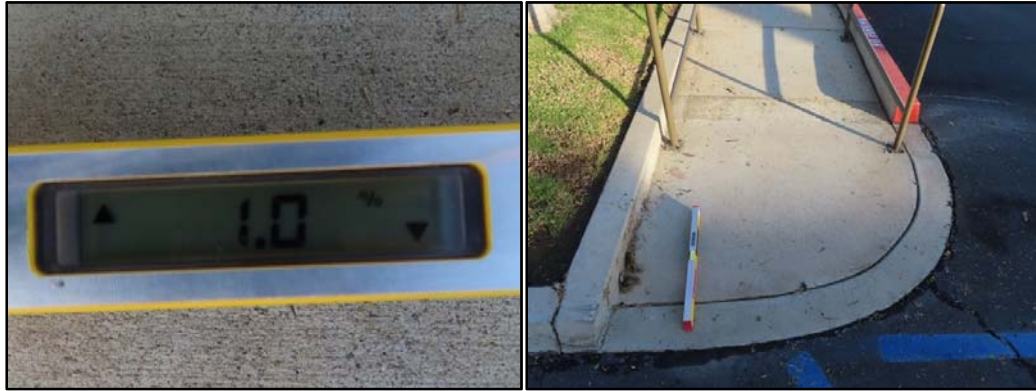
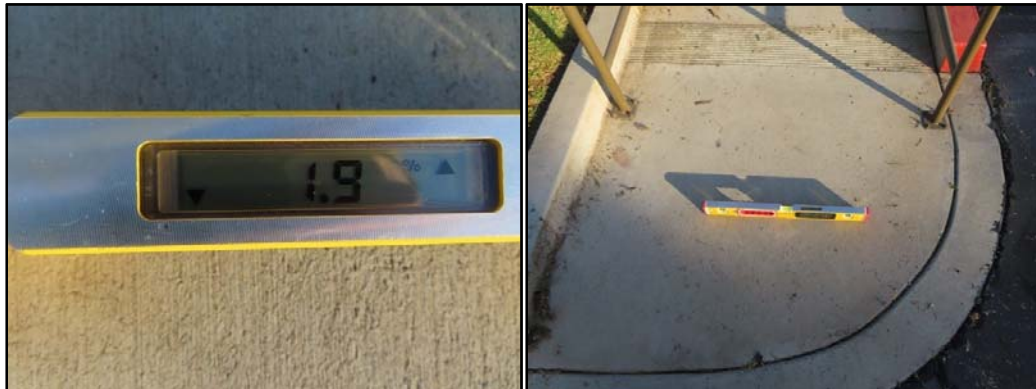
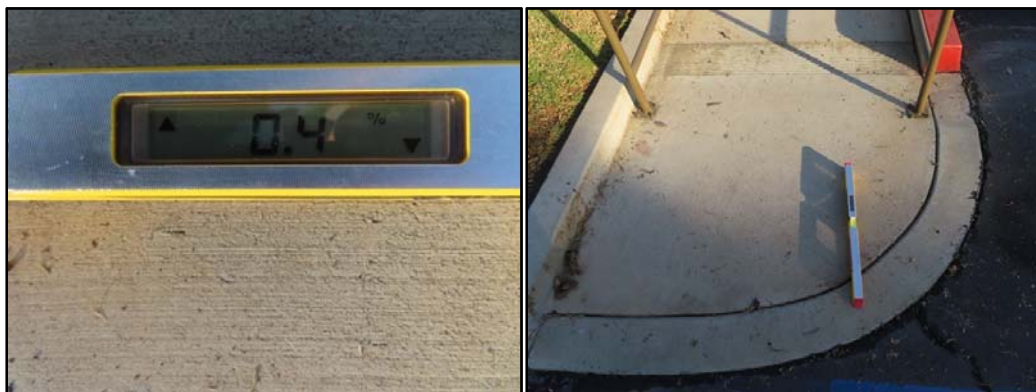
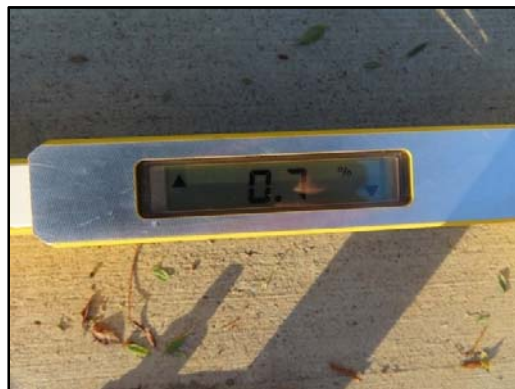
7	Ramp – Landing Slope	Is the slope of top, bottom and intermediate landings no more than 1:48? (≈ 2.1%)	11B- 405.7.1	11B- 405.7.1	4.3.7	405.7.1	Barrier: The slope of the bottom landing of the lower ramp is 3.9%. Barrier Removal: Remove and replace landing. Photos: 461 thru 477
---	-------------------------	---	-----------------	-----------------	-------	---------	--

Photos from LCM Review of Corona Report Show bottom landing slope ranges from 0.4% to 2.4%.

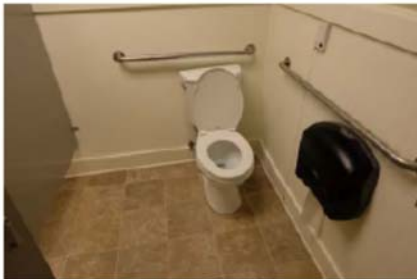
North Euclid # 0438

55. We found many incorrect measurements in our review of Plaintiffs' experts' reports such as the toilet compartment at North Euclid pictured below. The Plaintiffs' report listed this as an alleged violation with a width of 57.375". No photo of their measurement was provided, but our measurement showed 59.875"—well within construction tolerance for the ADA 60" ADA requirement for this element.

150	Toilet Compartment – Clear Width	Is the interior width of the toilet compartment a minimum 60" wide?	11B-604.3.1	11B-604.3.1	4.17.3 and Fig. 30(a).	604.3.1	Barrier: The compartment is not wide enough, measured at 57.375" wide. Barrier Removal: Relocate the partitions. Photos: 430 thru 459
-----	----------------------------------	---	-------------	-------------	------------------------	---------	---

Photos from LCM's field review of the North Euclid report.

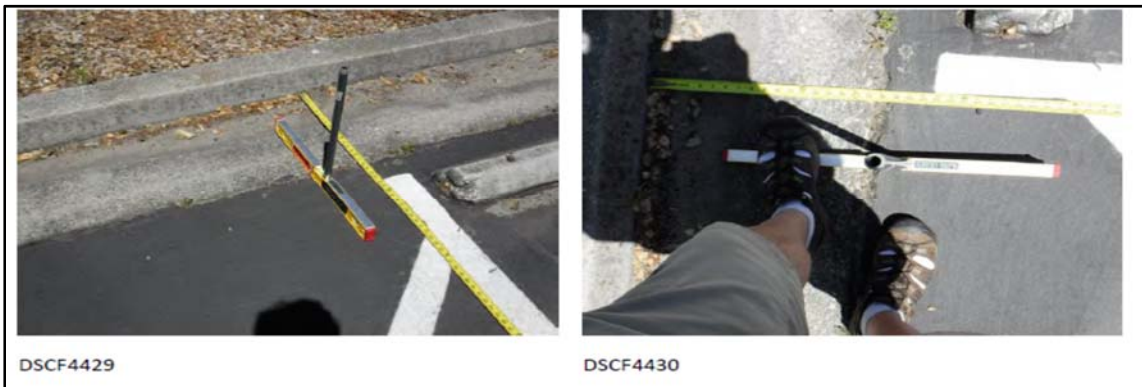
DSCF4431

56. Some of the Plaintiffs' findings were misleading about the severity of conditions at different Communities. One example of an overstated issue was at the Scotts Valley Community parking, where the Plaintiffs' report indicated that the slope of the parking space was measured up to 11.5%. This extreme slope measurement was taken in the gutter pan in front of the parking space—

159	Accessible Parking - Slope	Is the slope of the accessible parking spaces and access aisle serving them not more than 1:48 (2.1%) in any direction?	11B-502.4	11B-502.4	4.6.3	502.4	Photos: See aerial photo Barrier: The slope of the accessible parking spaces and access aisle exceeds 1:48, measured up to 11.5%. Barrier Removal: Overlay or replace the paving at the accessible parking spaces and access aisle as required to provide a slope not more than 1:48. I recommend accessible spaces be constructed in concrete. Photos: 4415 thru 4422
-----	----------------------------	---	-----------	-----------	-------	-------	---

Scotts Valley gutter pan slope

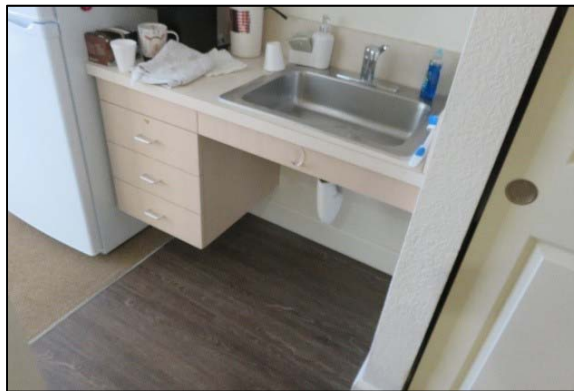
1 to unit 311 “except where noted”. However, I found that unit 120 was a unit with accessible features
 2 whereas unit 311 was a standard unit with no accessibility features—yet the Plaintiffs’ experts noted no
 3 differences between the units on their report, and the two units were in no way similar. This is a
 4 significant oversight. The differences between those two units are clearly seen in the photos below.

14 Unit 120 – Kitchenette photos that I took shows that Unit 120 is not similar to Unit 311:

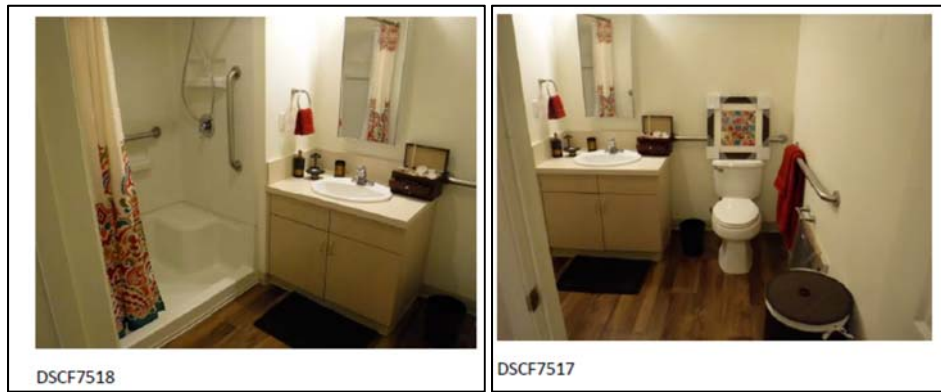
22 Unit 311 – Bathroom photos from Plaintiffs’ expert:

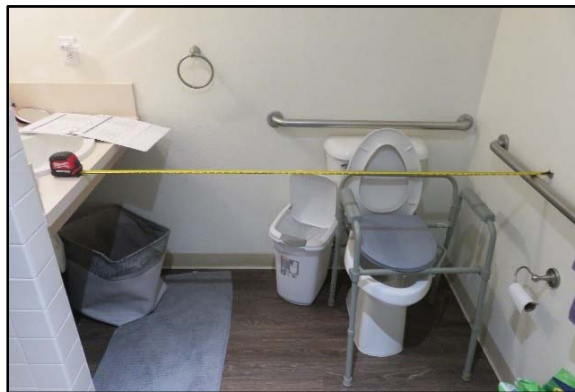
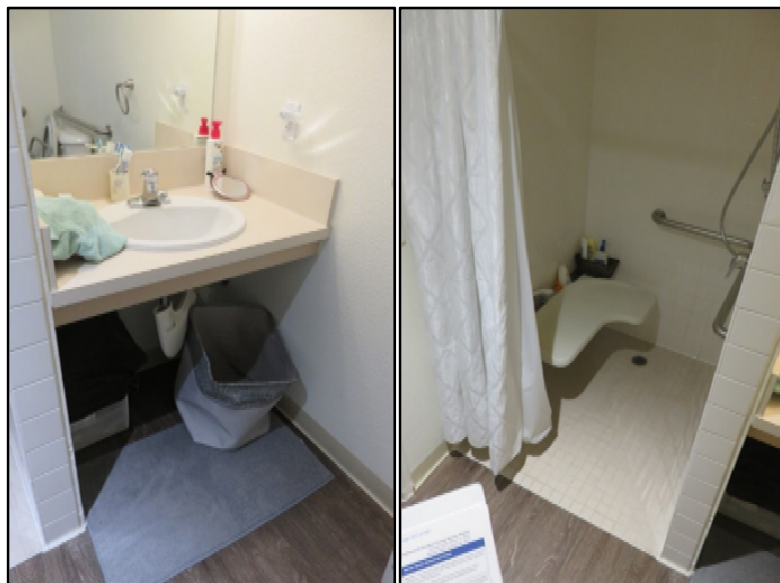
Unit 120 – Bathroom photos that I took shows that Unit 120 is not similar to Unit 311:

Unit 120 – Bathroom photos that I took shows that Unit 120 is not similar to Unit 311.

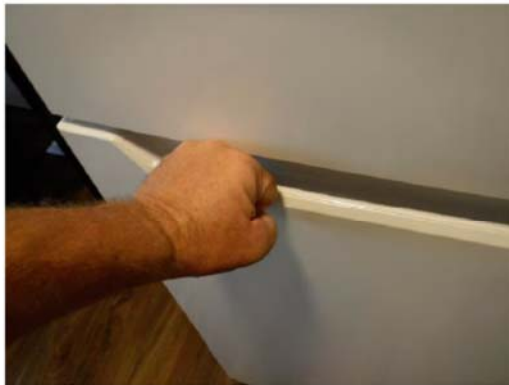
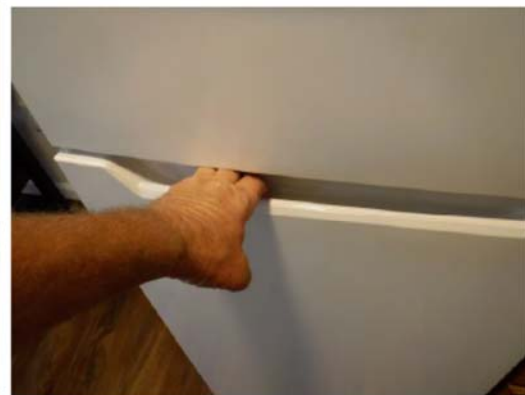
58. Other issues with the Plaintiffs’ reports included misinterpretation or misapplication of the codes and/or standards. One of the issues the reports listed as “common” relates to the accessibility of handles or controls. The accessibility codes and standards require operable controls to be usable without tight grasping, pinching, or twisting of the wrist. This is known as a performance standard as opposed to a technical standard because there is no objective way to measure for this characteristic. Some surveyors use a “closed fist test” to see if a control meets these performance requirements. While this test may be one method for trying to determine performance, it is not the technical standard, and should not be relied upon as the exclusive methodology for the usability of a control by someone with limited mobility or strength in their hands. The standard precludes tight grasping, pinching, or twisting of the wrist. For example, while the refrigerator handle space in the photographs below may not be large enough for a closed fist, it does not require a tight grasp, pinch, or twist to operate, and thus would not violate the accessibility standard.

Photo showing refrigerator handle space does not require a tight grasp, pinch, or twist to operate.
